**AFTER**  
**THE TSUNAMI**  
Rapid Environmental  
Assessment

Published in February 2005

Rapid Environmental Assessment conducted by the UNEP Asian Tsunami Task Force

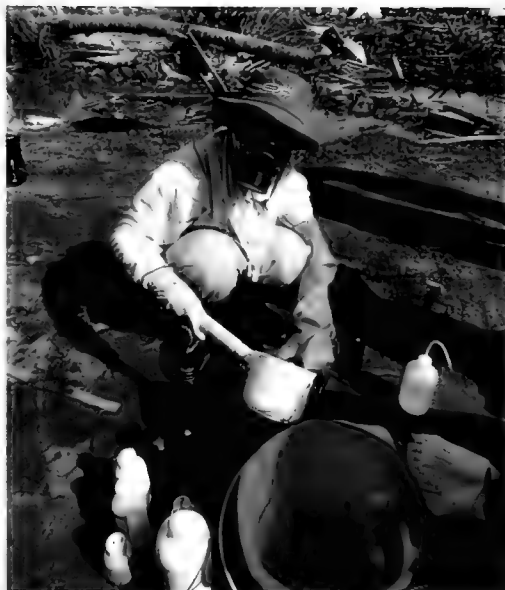
Banda Aceh, Indonesia (15 January 2005). An employee of the Indonesian Environment Ministry collects a water sample for analysis. Standing water left by the tsunami in Banda Aceh tested by the Indonesian Environment Ministry shows high levels of faecal coliforms, consistent with sewage contamination.

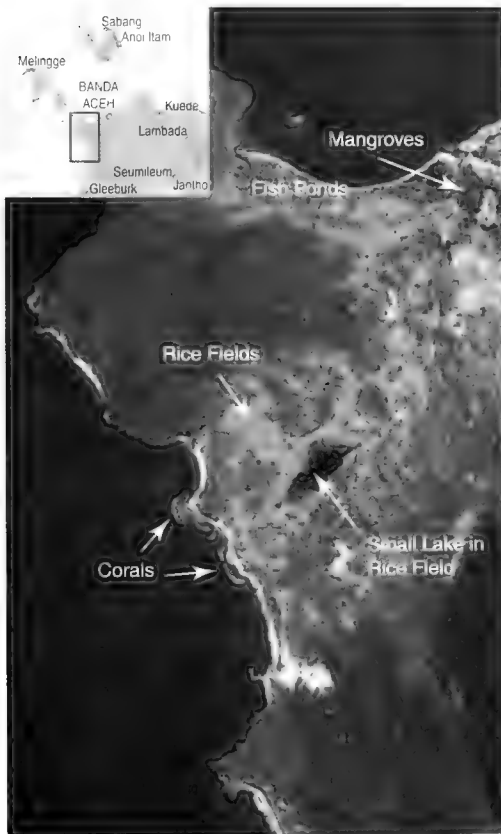
10 Jan 2003

These images show a combination of a rocky, hilly headland along with a small river delta and swampy coastal strip. A low-lying wetland area connects the northern and western ocean fronts. An integration of natural and agricultural ecosystems operating prior to the tsunami combined rice cultivation, and fish/shrimp ponds (tambak), alongside natural delta mangrove forests and wetlands. Coastal forests and onshore reefs are also present. The effect of the tsunami is clearly evident. It scoured out the low lying delta land, destroyed fish ponds and removed mangrove cover. Volumes of soil and silt have evidently been carried out to sea expanding the area of the small lake by a factor of approximately 10. There has been removal of the sandy beaches (important in some locations for turtle nesting) and deposition of silt or mud on the reef. Apparently minor effects on the integrity of the rocky vegetated shoreline surrounding the headland are likely due to the resistant nature of the substrata, as well as dense natural vegetation cover and the sloping nature of the shore.

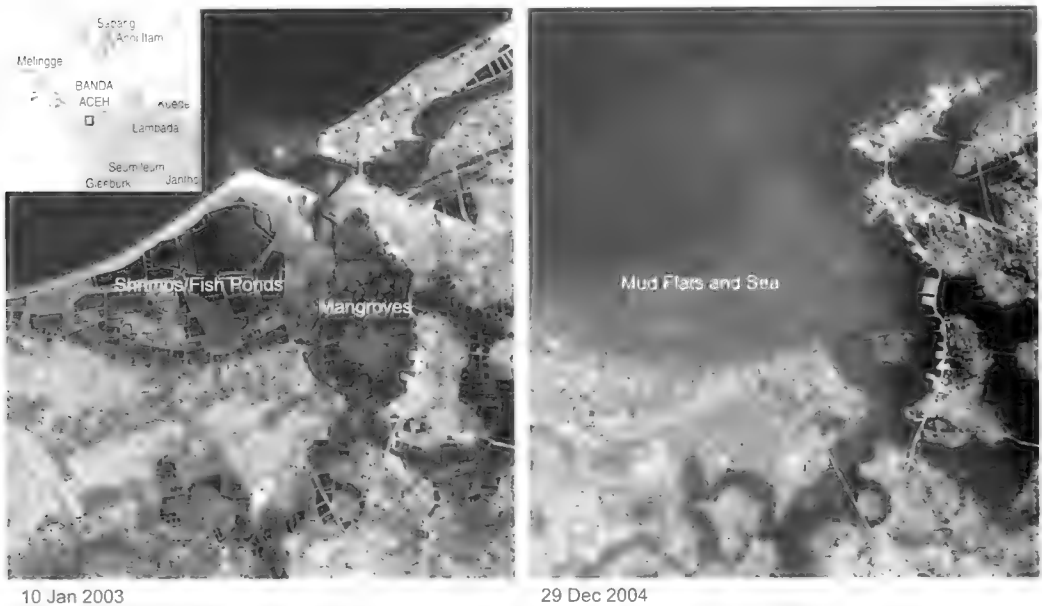
Case study: Impact on aquaculture

These images show a close-up view of the northern coastal area of case study 1. Features include a swampy coastal strip of land which has largely been converted to tambak. Part of the inland estuary is covered in *Rhizophora* mangroves, which are important spawning and nursery grounds for the milkfish and prawns traditionally raised in the tambak ponds. Further tambak ponds are located inland on the estuarine system. The post-tsunami image shows the devastating effect of the tsunami on the low-lying lands. The force of the water is able to travel up estuarine systems, often up to 6 kilometres inland. The western strip of coastal sandbar has been completely removed and tambak ponds destroyed, along with the majority of the mangroves. Clearly, a vast volume of material was carried out into the ocean. Devastating effects on housing infrastructure are also evident.

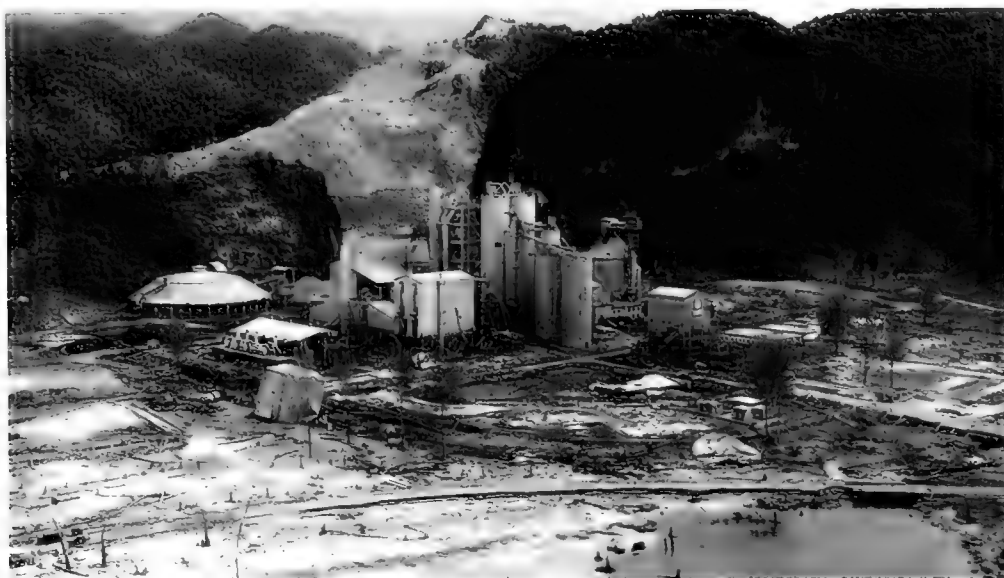
Lhok Nga, Indonesia (5 January 2005). Aerial view of a cement factory at Lhok Nga, south of Banda Aceh, Indonesia. The plant employed more than 600 people before the earthquake. The tsunami damaged an estimated 80 per cent of the facility and killed one-third of the workers. © Reuters/Choo Youn-Kong

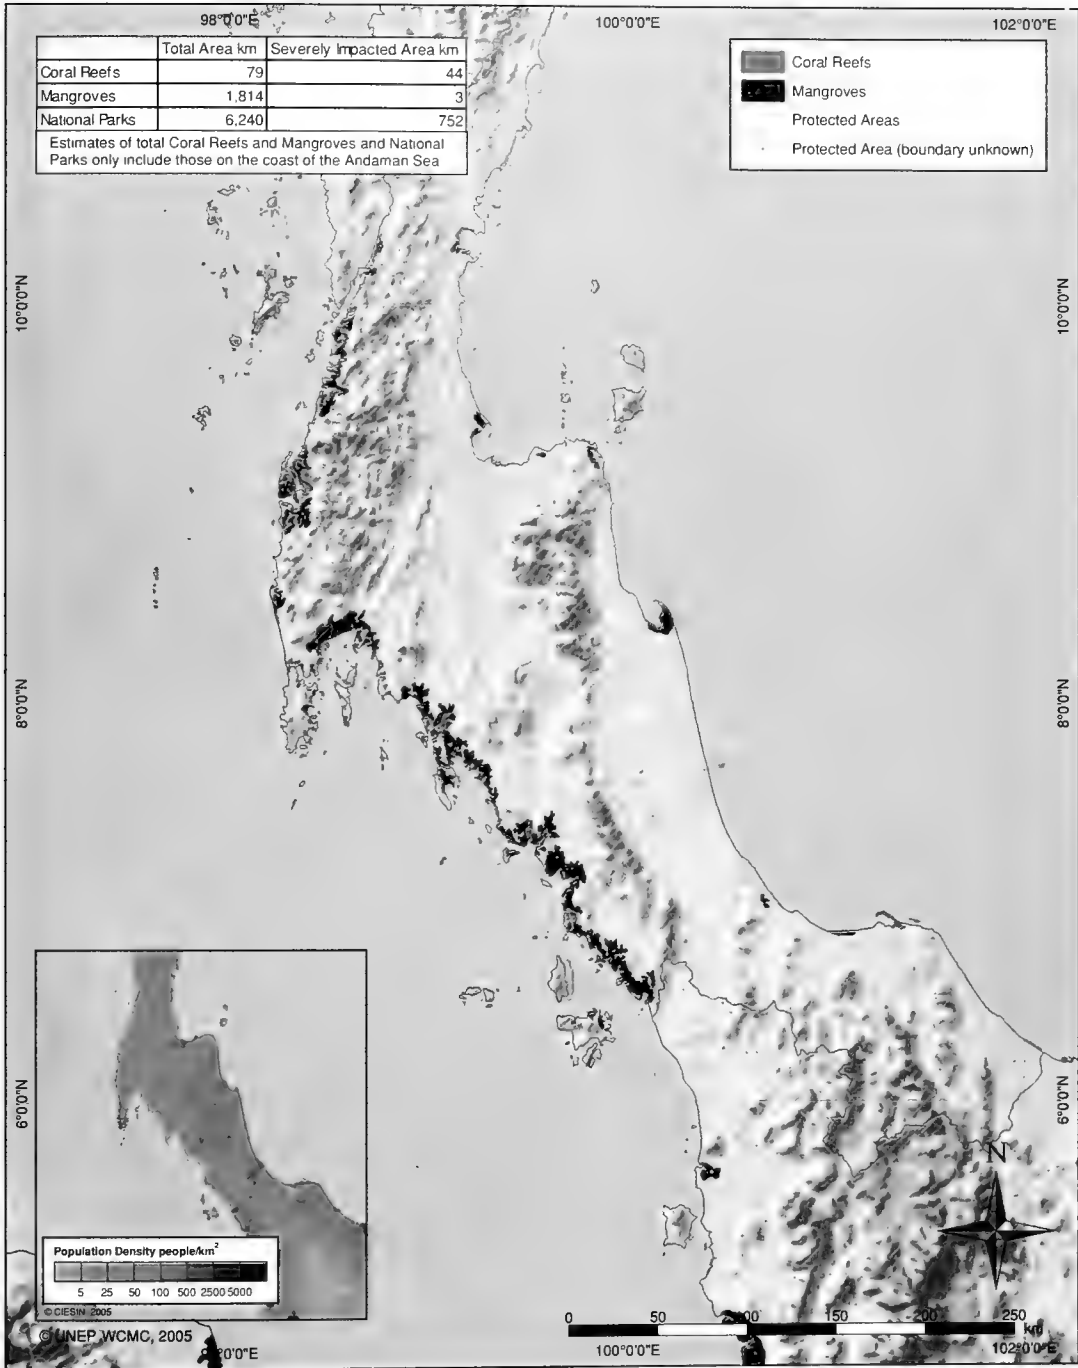
Priority Ecosystems and Protected Areas in Thailand

All data on Protected Areas, Coral Reefs, Seagrasses and Mangroves are available from UNEP WCMC databases.  
Data on population density kindly provided by CIESIN.

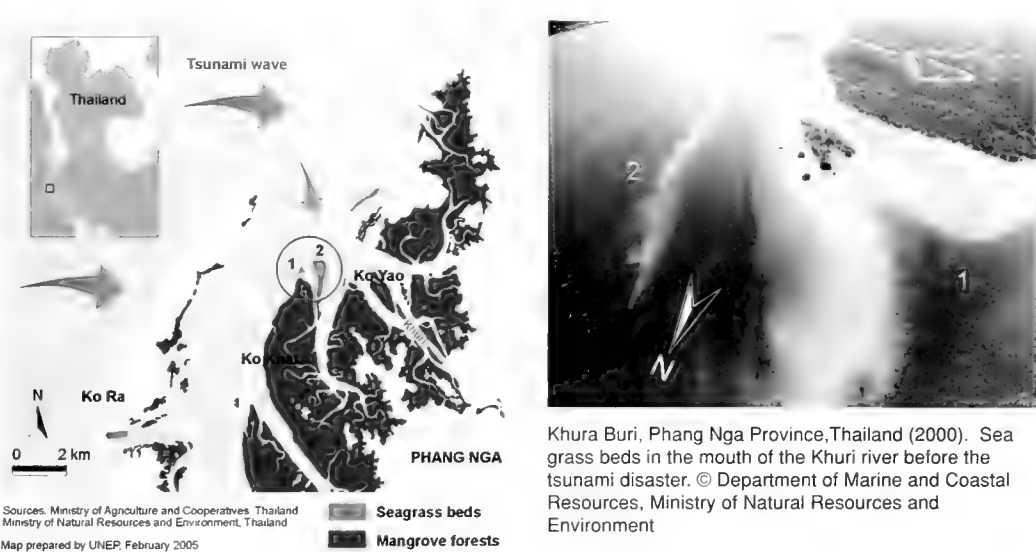
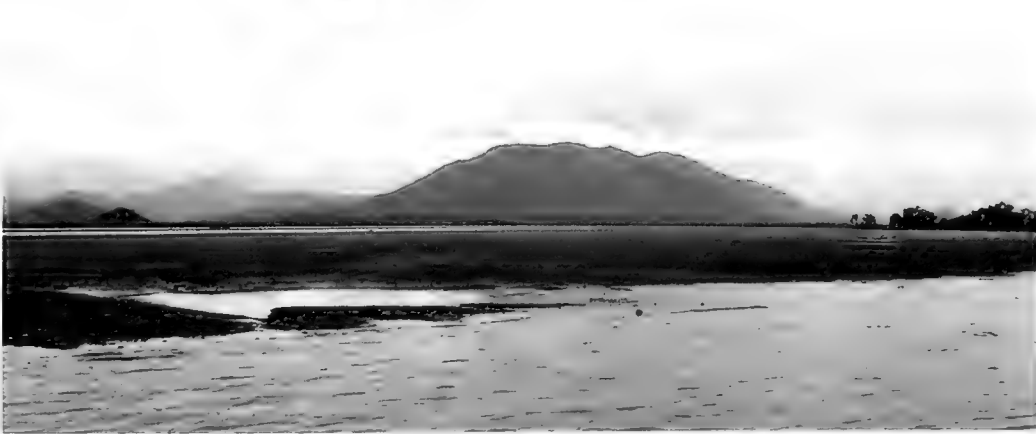
Sea grass beds are known to help stabilize the coastline. In Khura Buri, in the severely impacted province of Phang Nga, sea grass beds appeared to have mitigated coastal erosion in the inter-tidal zones. This is illustrated by the sea grass beds in the mouth of the Khuri river (circled in blue on the map).

Khura Buri, Phang Nga Province, Thailand (January 2005). Sea grass beds in the mouth of the Khuri river helped reduce coastal erosion in the inter-tidal zone, although they suffered from siltation and slight surface erosion. © Department of Marine and Coastal Resources, Ministry of Natural Resources and Environment.

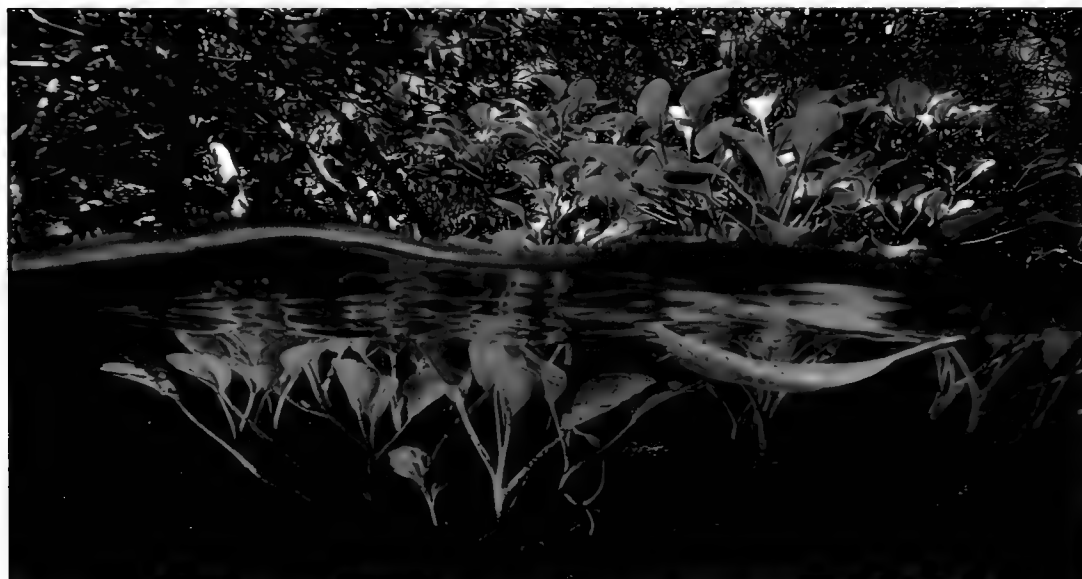
Mangrove roots, Thailand (undated file picture). In Phang Nga, the most affected province of Thailand, large mangrove forests in the north and south of the province significantly mitigated the impact of the tsunami, reducing the energy of the waves and providing protection to inland habitats. © Bojan Brecelj/Still Pictures

Mangrove forests are known to stabilize banks, protect reefs from terrestrial sediments, host a rich diversity of marine and avian wildlife and provide shelter among their roots for juvenile fish. They can also help protect coastal populations from tidal waves caused by natural phenomenon, such as typhoons and earthquakes. In Phang Nga, the most affected province of Thailand, large mangrove forests in the north and south of the province have significantly mitigated the impact of the Tsunami. They suffered damage on their seaside fringe, but reduced the tidal wave energy, providing protection to the inland population.

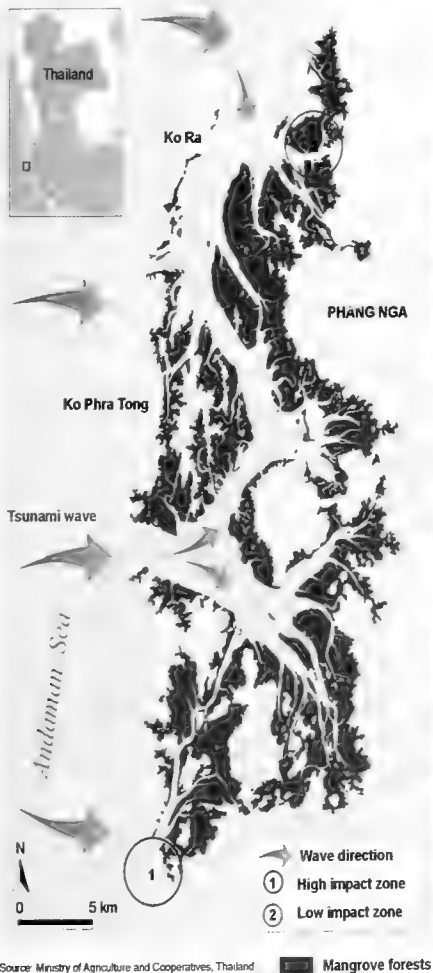
Khura Buri, Phang Nga Province, Thailand (January 2005). Small fishing village unaffected by the tsunami thanks to the protection of mangrove forests (location "2" on the map).

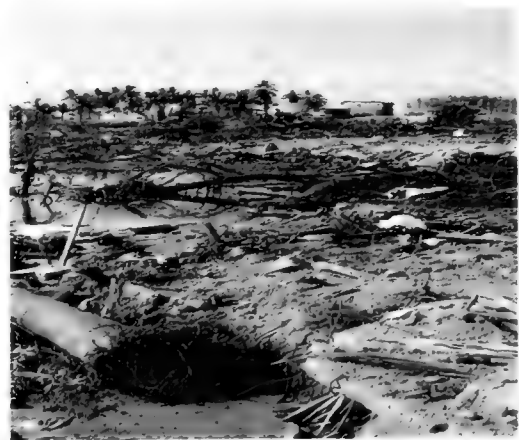
Phang Nga Province, Thailand (January 2005). Coastal area not protected by mangrove forests and severely impacted by the tsunami (location "1" on the map).

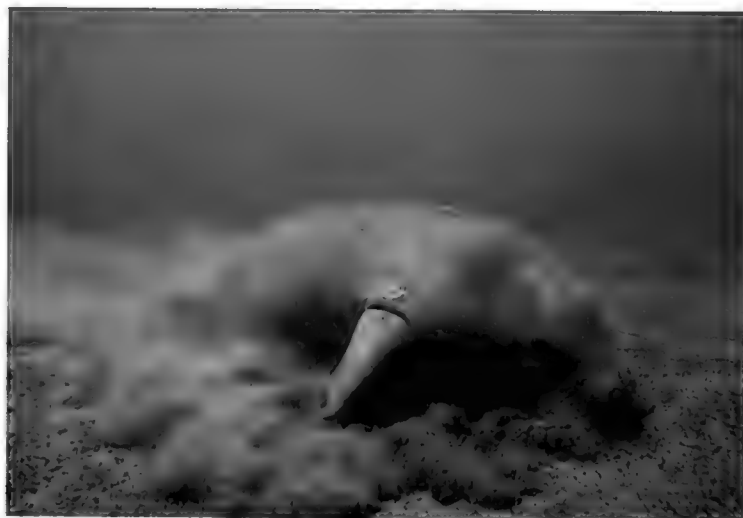
Dugong feeding on sea grass (undated file picture). The sea grass beds along the Andaman coast of Thailand cover an area of 7,937 hectares. Sea grass habitats are important for fisheries and as grazing areas for marine fauna, such as the Green turtle and the dugong. Sea grass meadows covering the inter-tidal zone appear to have prevented soil erosion during the tsunami. © Kelvin Aitken/Still Pictures

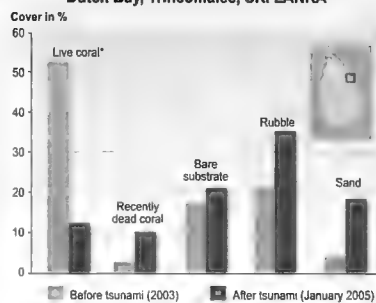
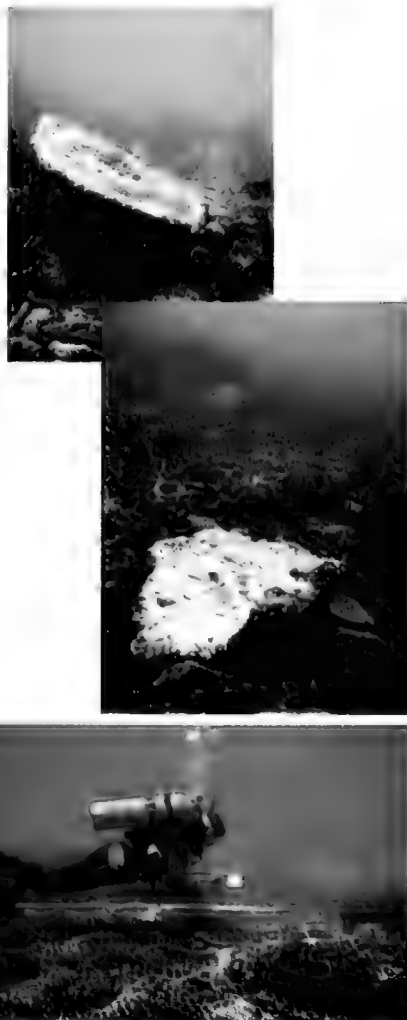
**Tsunami-induced changes in the benthic cover  
Dutch Bay, Trincomalee, SRI LANKA**

- Extreme mechanical damage, with nearly half of the coral reef area ripped off, including the reef base (limestone substrate) in some places, turning the reef into fields of rubble and sand. Three quarters or more of the remainder has also been severely damaged.

- Granite rocks and boulders 20–50 centimetres in diameter have been shifted, particularly around a rock patch near the shore.
- Virtually all remaining live corals had been damaged, and many *Acropora* colonies have been sheared. Among standing thickets, most branches were loose and moving with the swell. Many table corals had been uprooted and toppled over.

- A lot of broken branches of live coral are being abraded in moving rubble beds. Many coral colonies were partially or entirely buried in rubble and sand.

- There were also signs of paling and bleaching in remaining massive colonies, most notably *Goniastrea* sp., *Porites* sp. and *Favia* sp. This may be caused by sediment stress and abrasion.

- Many soft corals were found ripped off the reef substrate and with severe tissue damage.
- There was very little evidence of litter, debris and sediment from land sources.

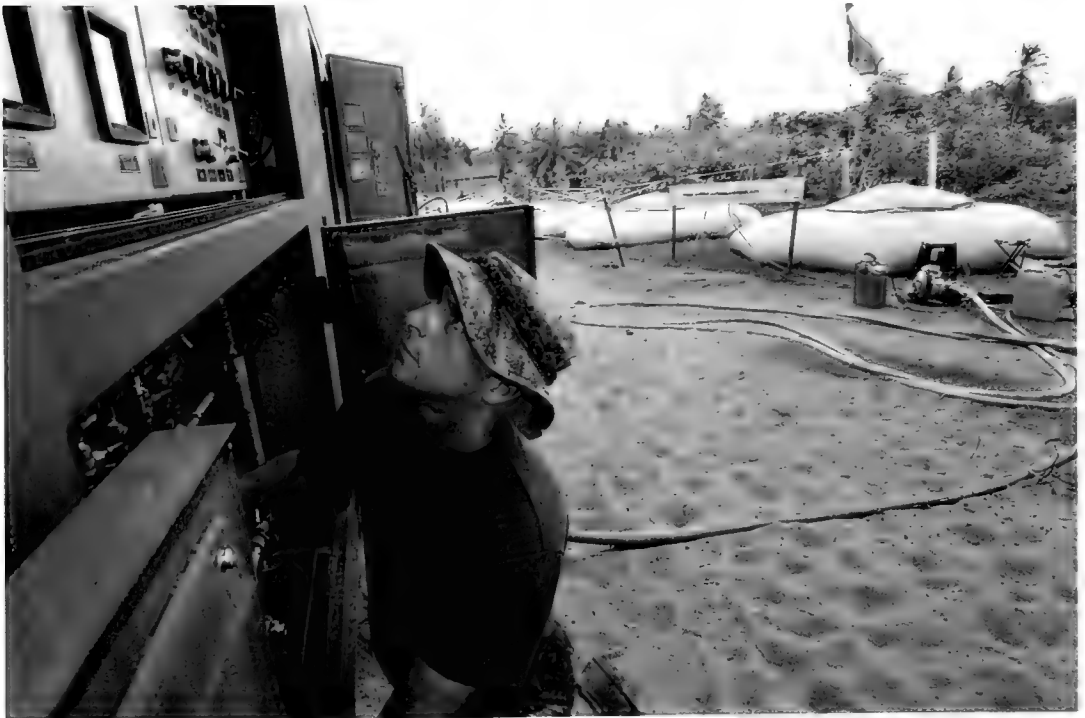
Kalmunai, Sri Lanka (3 February 2005). Checking the water purification machine in Sri Lanka's eastern town of Kalmunai. A 200-member Canadian military contingent is conducting relief operations on the east coast, providing clean drinking water for 80,000 tsunami survivors. © Prakash Singh/AFP/Getty Images

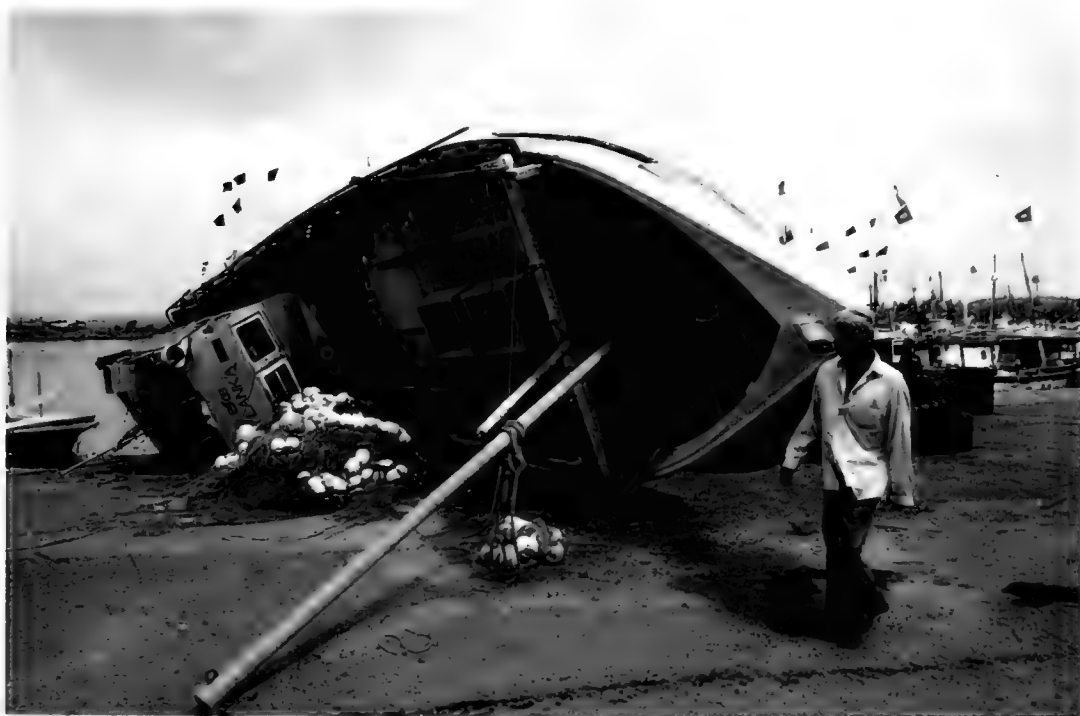
Mirissa, Sri Lanka (5 January 2005). A Sri Lankan man walks past the wreckage of a fishing boat tossed ashore by the tsunami in the southern coastal town on Mirissa. As many as 27,000 of the fatalities were fishermen, and two-thirds of Sri Lanka's fishing boats were wrecked, destroying livelihoods for many families. © Jimin Lai/AFP/Getty Images

Fishing and related small-scale food processing were affected the most by the disaster. Of the country's 29,700 fishing boats, about two-thirds were destroyed or significantly damaged, along with outboard motors, ice storage units, fishing gear and nets. Entire fishing communities were dependent on these fleets. Damage to the agriculture sector included the destruction of standing crops and home gardens, washing away of tree crops, and entry of sea water to productive fields which may render them unusable for many months. An estimated 27,000 jobs in the tourism industry were suspended by the tsunami, one third in officially-registered hotels and the rest in unregistered hotels and guesthouses. Many small businesses and informal traders catering to the tourism industry, (e.g., dive, souvenir, handicraft shops, and internet cafes) were damaged and are now facing a sustained period with far fewer customers. The main tourism season of January to March is likely to be lost entirely.

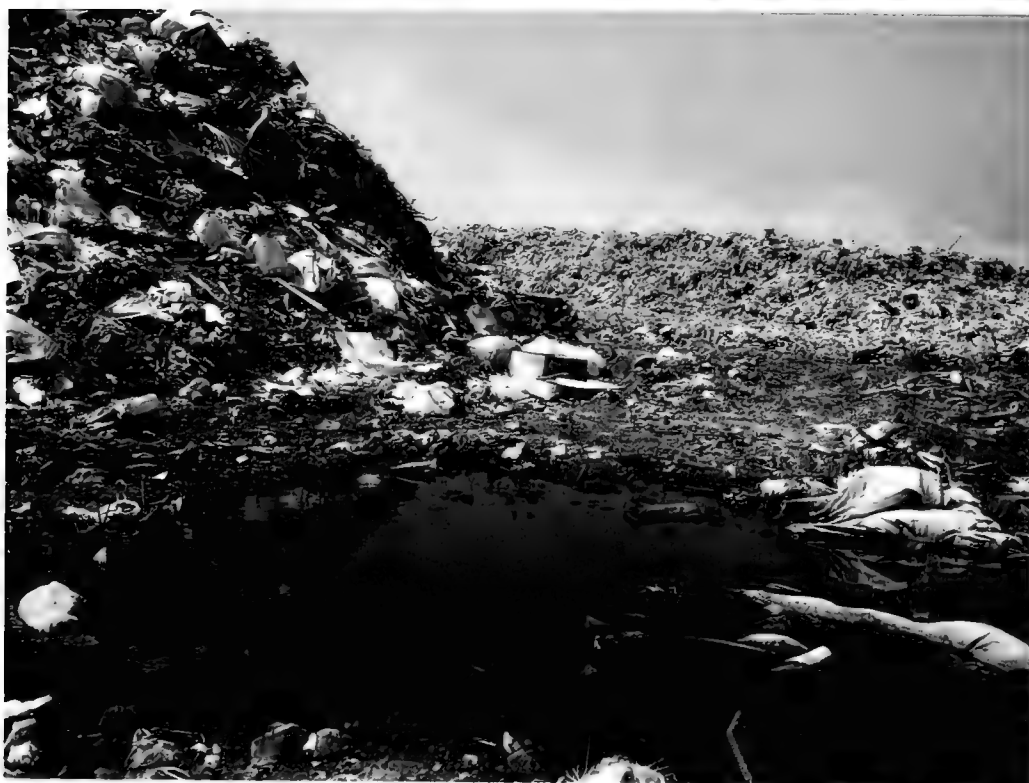
Asbestos roof sheeting at a dump site on Thilafushi island, Maldives, 14 January 2005

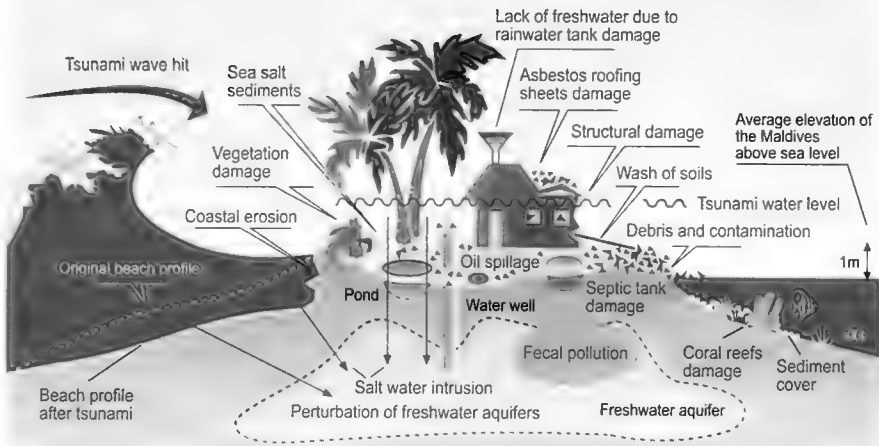
Environmental impacts of the Asian Tsunami in the Maldives

Atolls: 69 islands completely flooded, 30 islands half-flooded

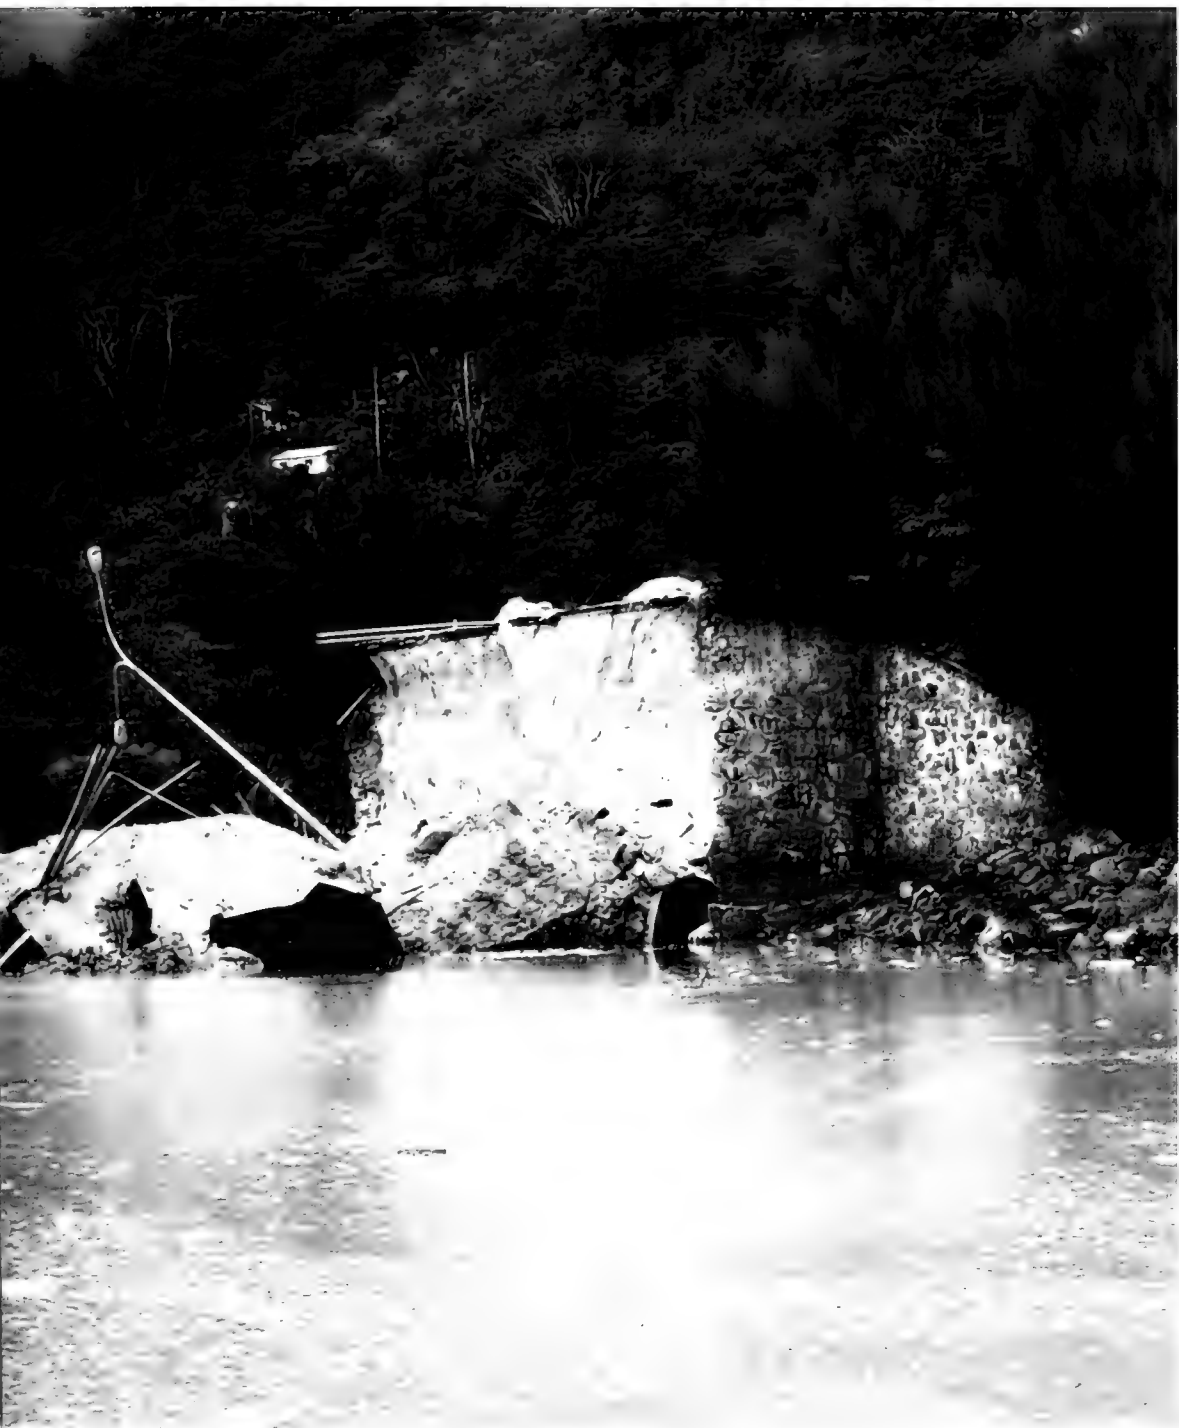
Seychelles (28 December 2004). This bridge linking the Seychelles international airport with the capital, Victoria was destroyed by the tsunami. The sea water surges flooded low lying areas of Mahé, Praslin and La Digue, and caused widespread damage to beaches, coastal vegetation, roads, bridges, houses and other infrastructure.

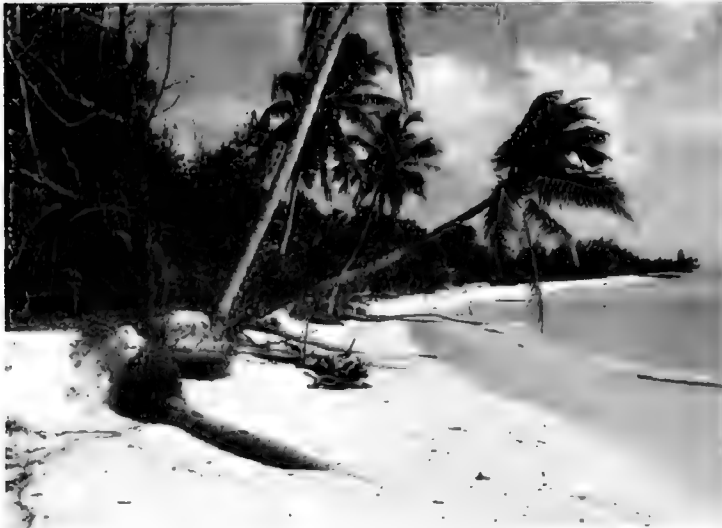
Anse Kerlan, Seychelles (5 February 2005). Eroded turtle nesting beach.  
© Mark Collins/UNEP

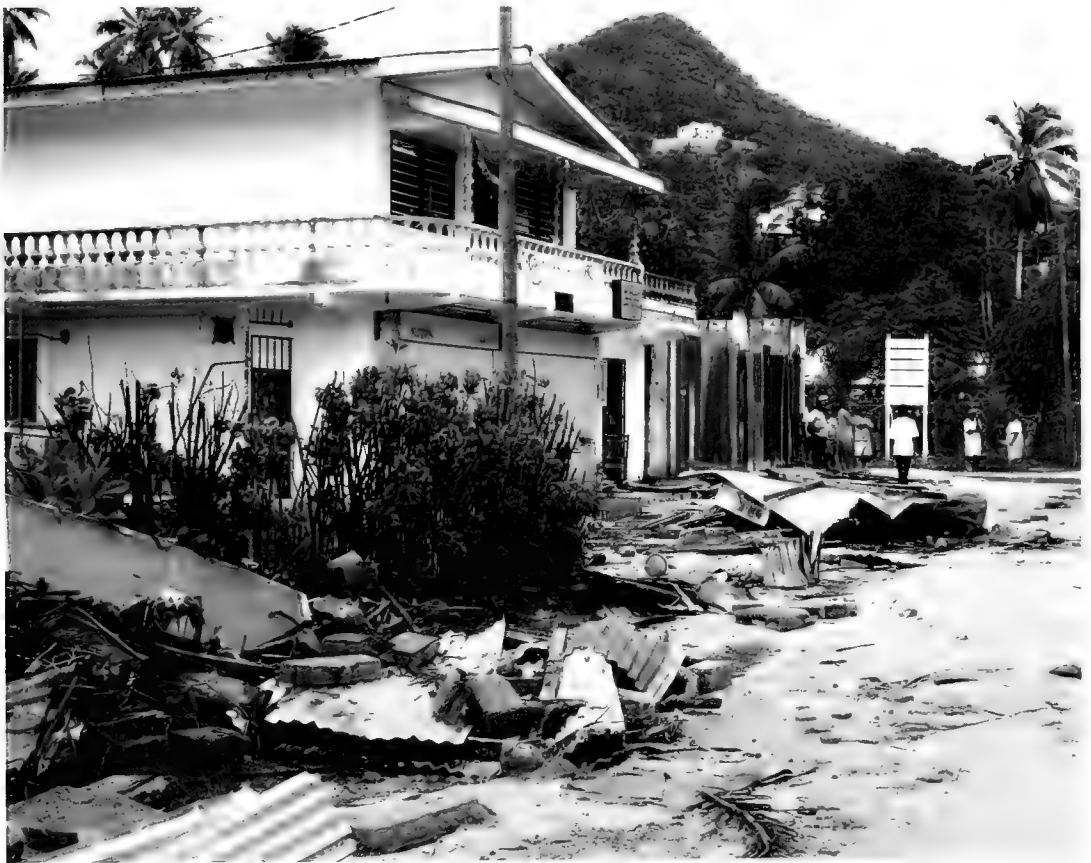
Mahé, Seychelles (26 December 2004). People assess the damage after the tsunami hit the Seychelles capital Mahé. Seawater surges flooded the low lying areas of Mahé, Praslin and La Digue and caused widespread damage to beaches, coastal vegetation, roads, bridges, houses and other infrastructure. The tsunami was followed on 27 December by extreme weather, with rainfall reaching 250 millimetres in the northern and central areas of Mahé. Torrential rains continued for several days, causing further damage to infrastructure, dwellings and vegetation. © Terence Fortune/Reuters

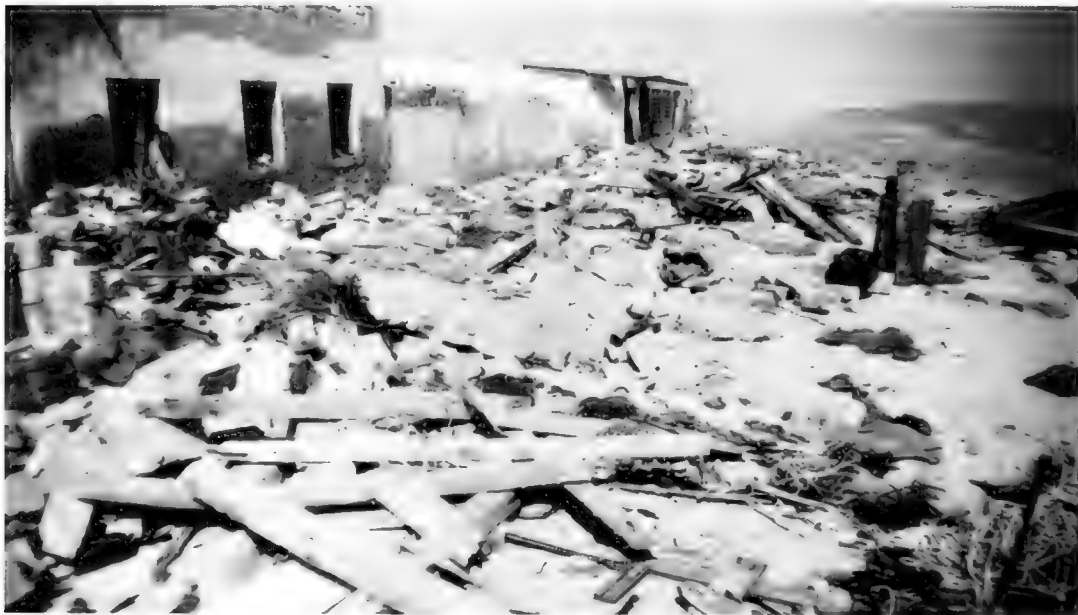
Dabut, Yemen (28 December 2004). Relative to the countries of southeast Asia, damage in Yemen was much less, mainly because of its distance from the epicentre of the earthquake, and the protection it receives from the Indian Peninsula and Horn of Africa. Nevertheless, the impacts on the livelihoods of local people, especially fishermen, were significant, as many of them lost their main form of income. © Al Mahra Rural Development Project

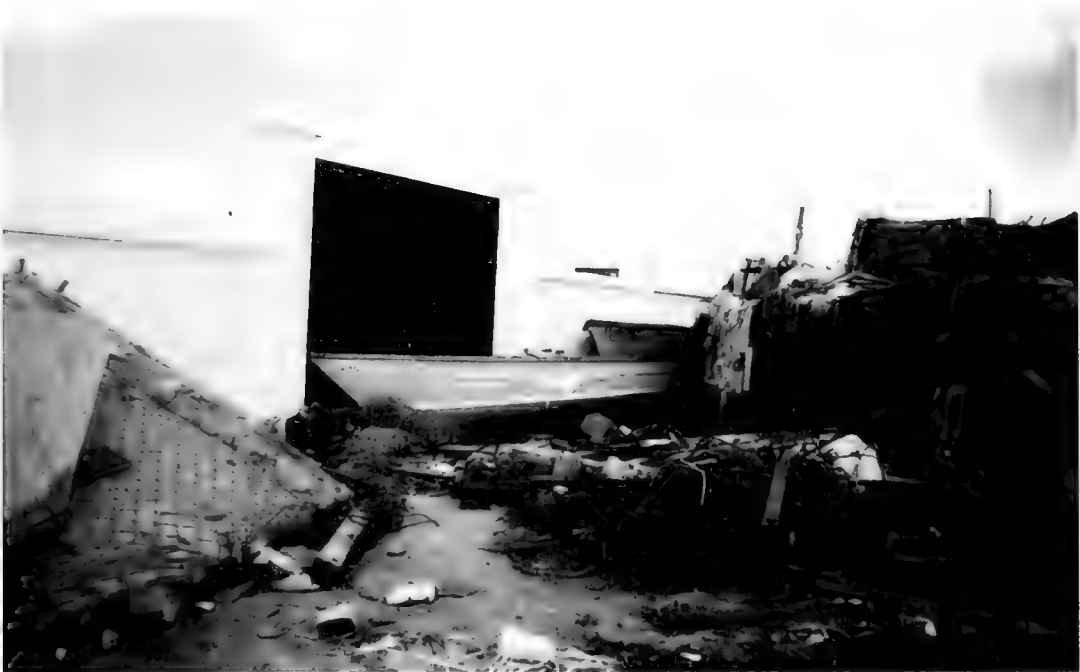
Muhayfif, Yemen (28 December 2004). Tsunami debris outside the offices of the Al Mahra Fisheries Association.  
© Al Mahra Rural Development Project

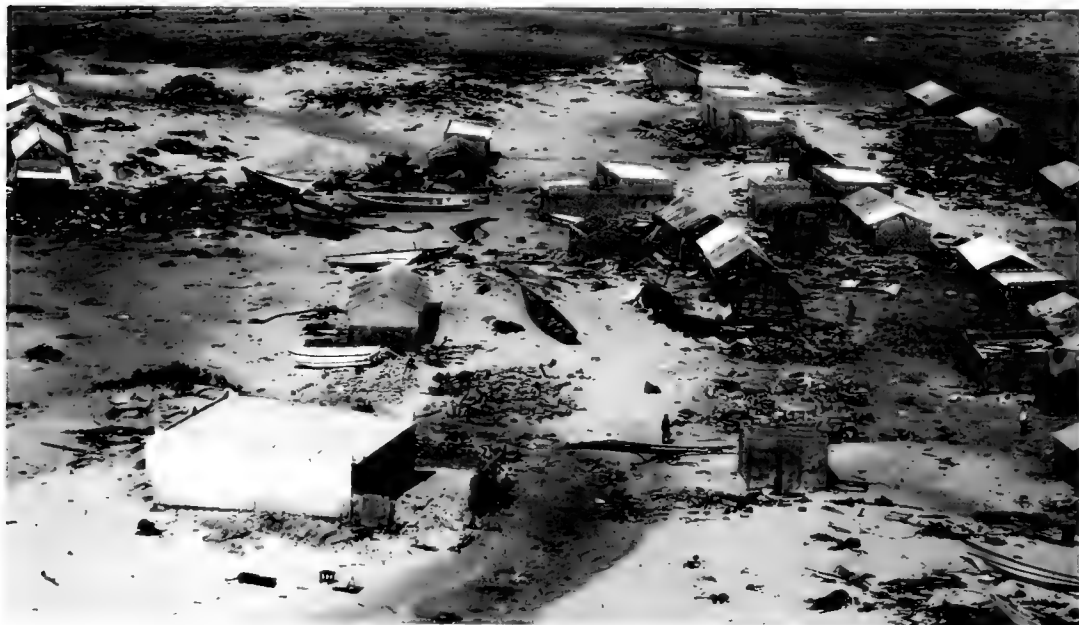
Hafun, Somalia (31 December 2004). Aerial view of the aftermath of the tsunami that struck Harun, Somalia on 26 December. The tsunami killed more than 300 people and destroyed homes, boats and fishing equipment. About 18,000 households were estimated to be directly affected and in need of urgent humanitarian assistance. © AFP/Getty Images
